# Inspection Report

**Property Address:**  
123 Main Street  
Anytown IL 00000

**Pro Home Inspections, Inc.**

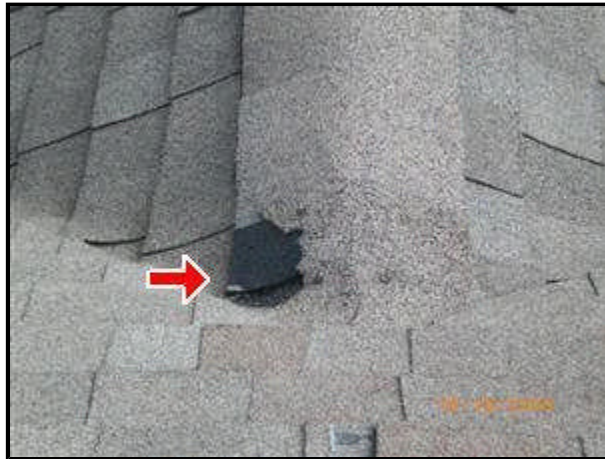
**1.0** Broken shingle at valley, front of roof. Left uncorrected water penetration could occur. Recommend roofer correct as needed.

1.0 Picture 1 Broken shingle

Broken shingle at valley, front of roof. Left uncorrected water penetration could occur. Recommend roofer correct as needed.

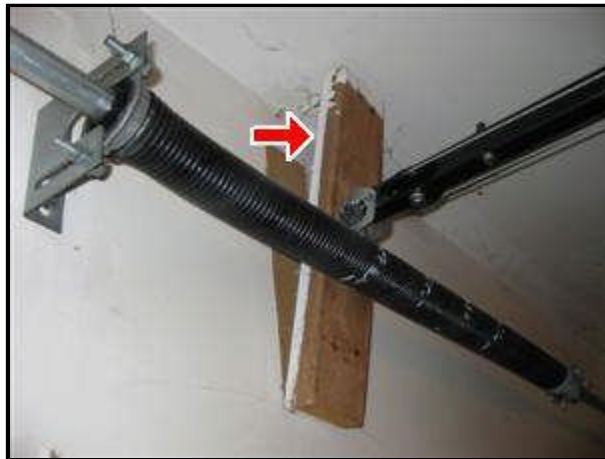
**3.0** Support for garage door opener has pulled away from header above garage door. Recommend support be resecured.

3.0 Picture 1 Support needs to be secured

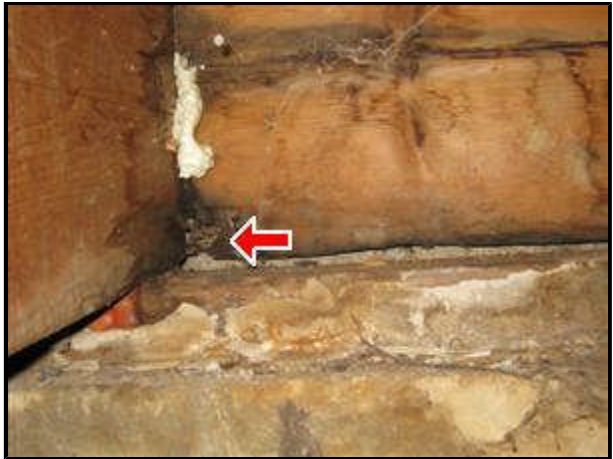
5.0 Picture 2

**5.0** Rim joist at crawl space is rotted allowing moisture and outside air to enter. Recommend carpenter investigate further to determine cause of rot and repair as necessary.

5.0 Picture 1 Rotted rim joist

Rim joist at crawl space is rotted allowing moisture and outside air to enter. Recommend carpenter investigate further to determine cause of rot and repair as necessary.

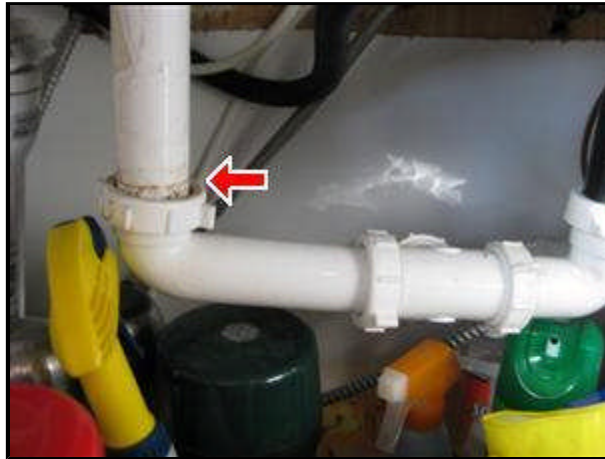
- 📍 **6.0** (1) PVC drain piping under kitchen sink is missing "P" trap and has a stressed joint. Recommend qualified plumber repair as needed.

6.0 Picture 1 Missing "P" trap

(1) PVC drain piping under kitchen sink is missing "P" trap and has a stressed joint. Recommend qualified plumber repair as needed.

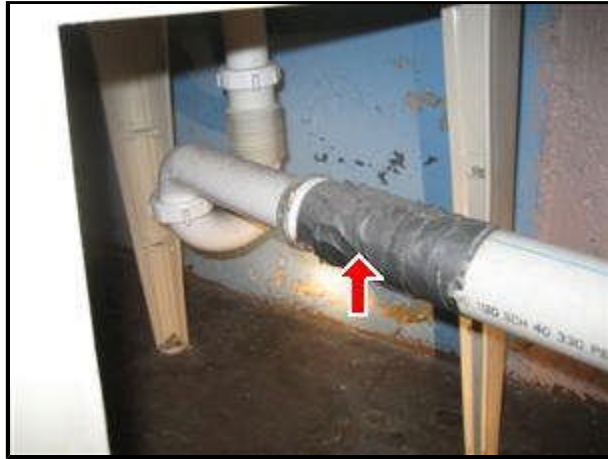
- 📍 (2) "Handyman" plumbing repair at laundry room tub. Recommend plumber correct as needed.

6.0 Picture 2 "Handyman" repair

(2) "Handyman" plumbing repair at laundry room tub. Recommend plumber correct as needed.

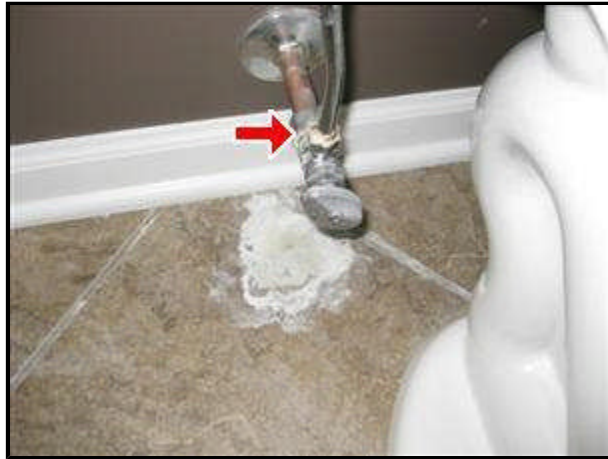
**6.1** (1) Shut off valve to Master bath toilet is leaking. Recommend plumber correct as needed.

6.1 Picture 1 Leaky valve

(1) Shut off valve to Master bath toilet is leaking. Recommend plumber correct as needed.

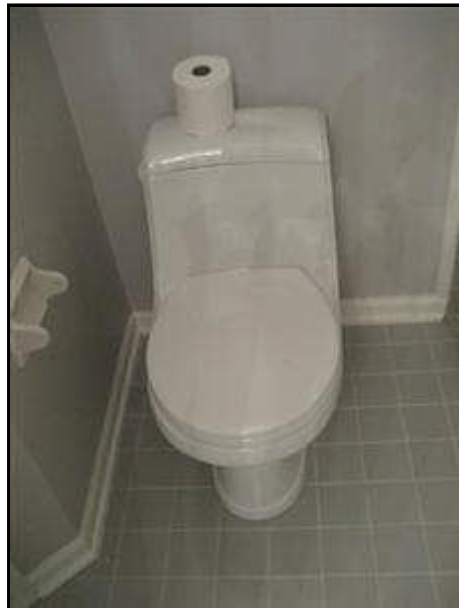
(2) Toilet at second floor hall bath is loose. This is a relatively inexpensive repair, however if left uncorrected, can damage subfloor leading to expensive repairs. Recommend a qualified plumber secure toilet to floor.

6.1 Picture 2 Loose at floor.

(2) Toilet at second floor hall bath is loose. This is a relatively inexpensive repair, however if left uncorrected, can damage subfloor leading to expensive repairs. Recommend a qualified plumber secure toilet to floor.

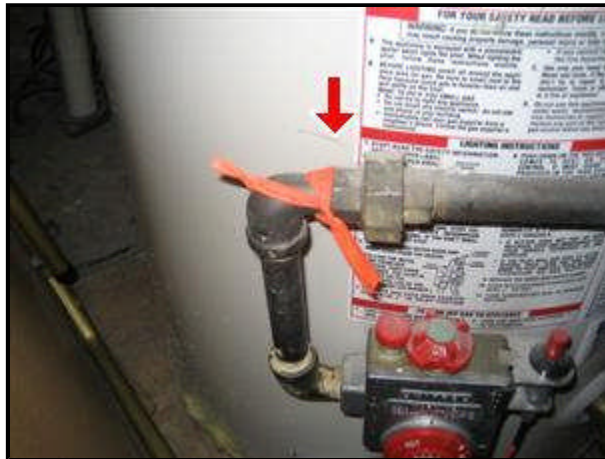
6.4 (1) Gas leak detected at connection to water heater. This is a potential safety hazard. Recommend qualified plumber correct as needed.

6.4 Picture 1 Gas leak

(1) Gas leak detected at connection to water heater. This is a potential safety hazard. Recommend qualified plumber correct as needed.

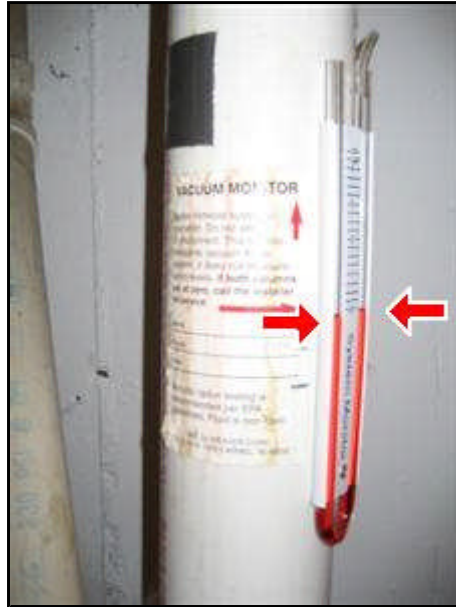
(2) Radon mitigation system is not operating. Note: level of red tinted water is even indicating no suction on basement slab. Recommend Radon mitigation company correct as needed.

6.4 Picture 2 Mitigation system inoperative

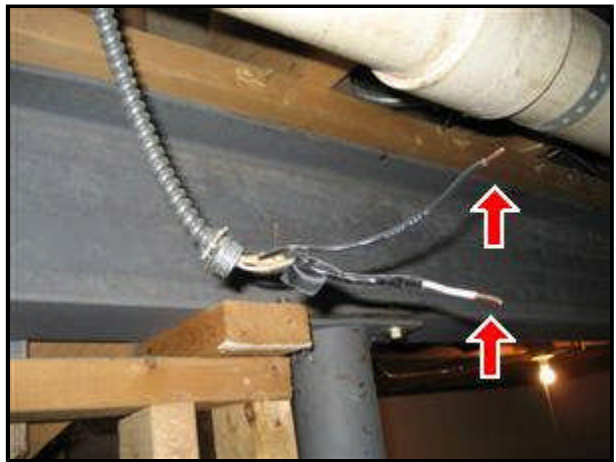
**7.3** Open electrical wiring in basement SE corner. Circuit tester indicated no electrical current. Recommend unused wiring be removed by electrician.

7.3 Picture 1 Open wiring

Open electrical wiring in basement SE corner. Circuit tester indicated no electrical current. Recommend unused wiring be removed by electrician.

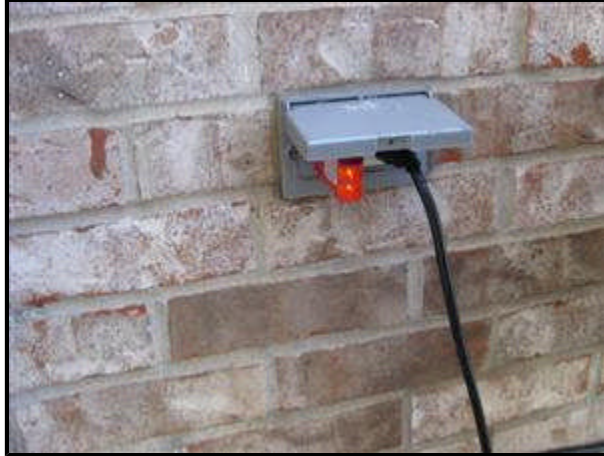
**7.5** GFCI (ground fault circuit interrupter) at front of house will not "trip" when tested. This is a common

condition found in exterior units and is relatively inexpensive to correct. This should be considered a safety hazard. Recommend a qualified electrician replace GFCI receptacle with new.

7.5 Picture 1 Will not "trip"

GFCI (ground fault circuit interrupter) at front of house will not "trip" when tested. This is a common condition found in exterior units and is relatively inexpensive to correct. This should be considered a safety hazard. Recommend a qualified electrician replace GFCI receptacle with new.

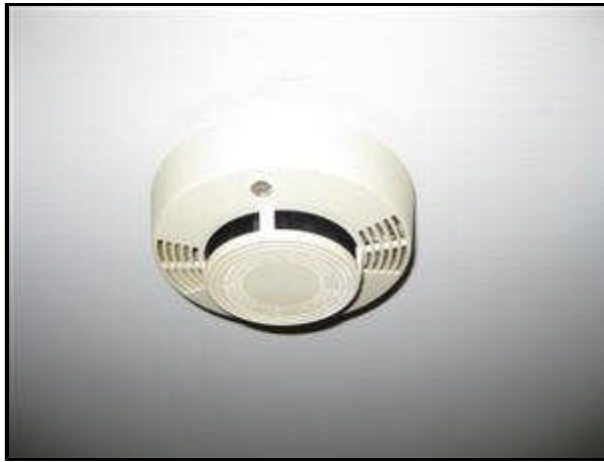
**7.7** Smoke detector at second floor hall by master bedroom is inoperative. This is a safety hazard. Recommend smoke detector be replaced with new.

7.7 Picture 1 Needs replacement

Smoke detector at second floor hall by master bedroom is inoperative. This is a safety hazard. Recommend smoke detector be replaced with new.

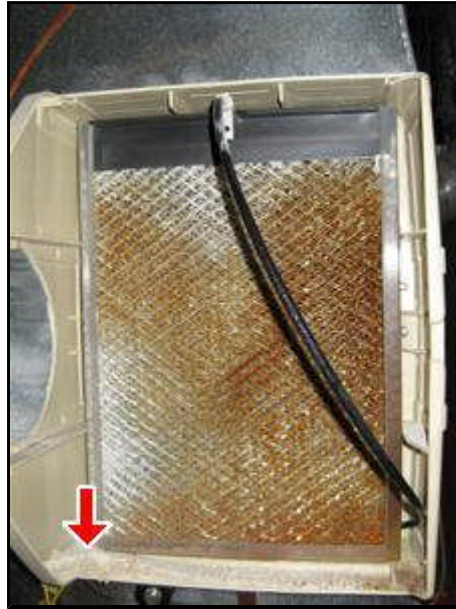
**8.3** (1) Humidifier at furnace has sediment build up and is rusted. Recommend filter be replaced/

8.3 Picture 1 Filter needs replacement

(1) Humidifier at furnace has sediment build up and is rusted. Recommend filter be replaced/

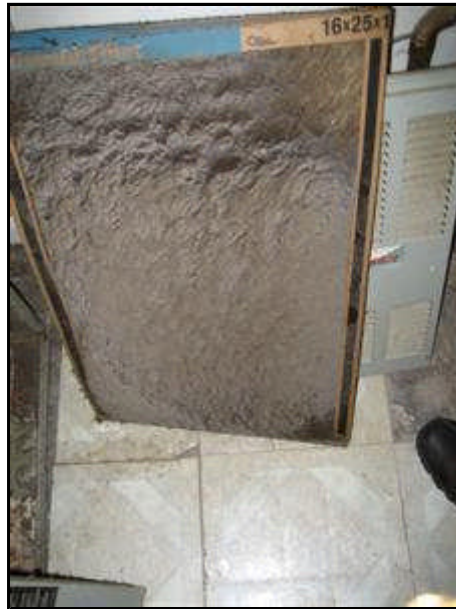
(2) Furnace air filter is completely plugged which has allowed unfiltered to enter furnace. Recommend new filter be installed and HVAC contractor inspect and clean furnace.

8.3 Picture 2 Plugged filter
